CONNECTICUT COASTAL BASIN
CLINTON, CONNECTICUT

BOULDER LAKE DAM CT 00518

PHASE I INSPECTION REPORT NATIONAL DAM INSPECTION PROGRAM

JULY 1981

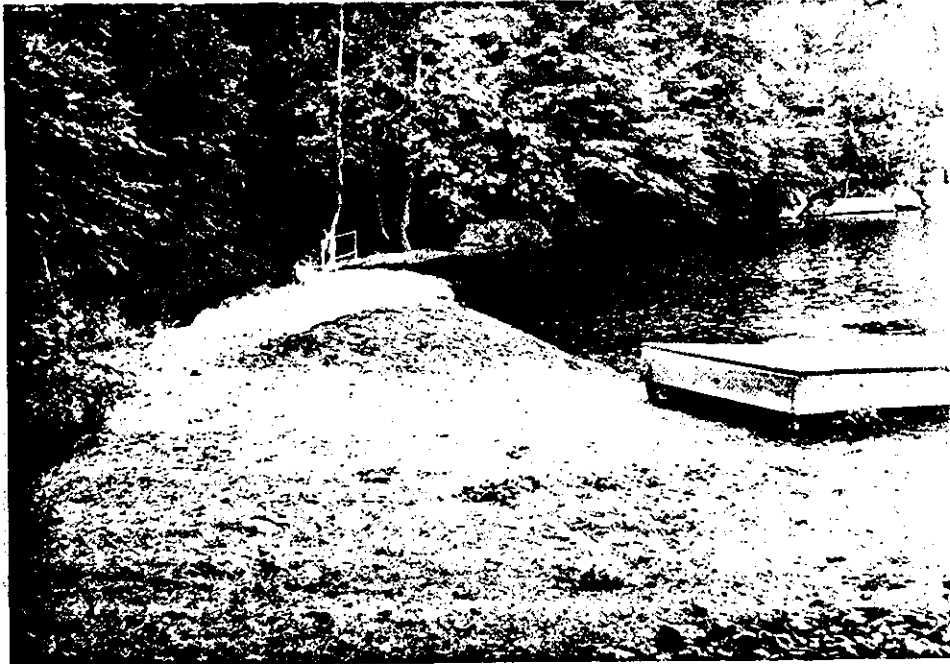
The dam is primarily an earthfill embankment with a rubbled stone and boulder faced wall on the downstream side. As shown in Photos 1 and 2, the crest of the dam consists of sand and gravel areas with several sand bags east of the spillway. Susceptible to erosion, the sand covered portion of the crest is loosely compacted, serving as a beach area to the lake (see Photo 3). The sand bags in conjunction with a low concrete block wall retain sand fill, deterring erosion in the vicinity of the spillway.

Photo 1 - View along crest of dam looking west.
Note two trees on the crest of dam in
background.

1. Surveillance of the dam during periods of heavy precipitation.
2. Monitoring of the seepage areas noted at the dam embankment.
3. Remove trees on crest at west end of dam embankment.
4. Provide adequate protection along crest of dam to prevent erosion and scouring.

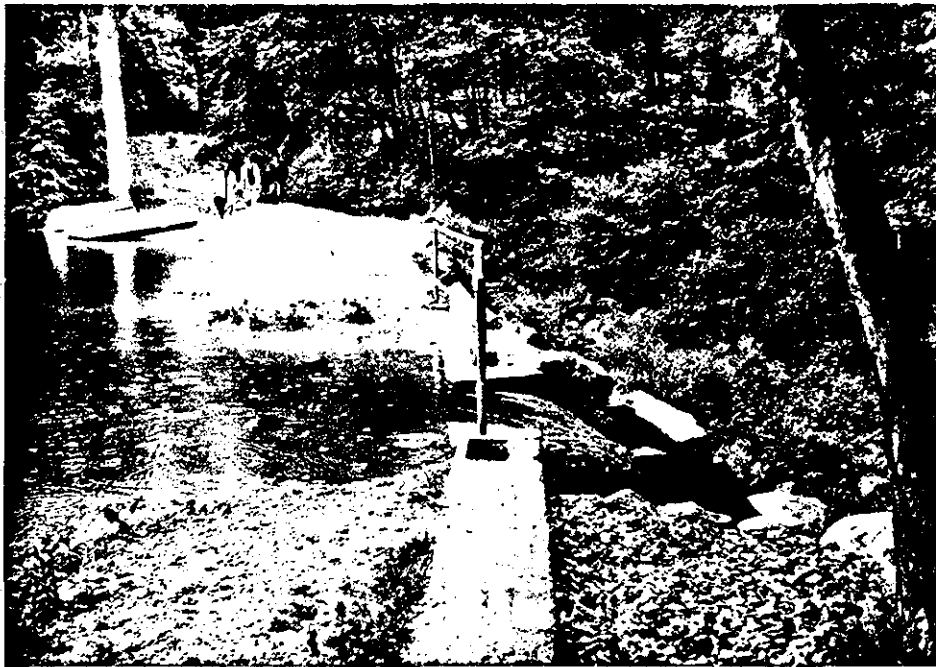
In addition to the narrow notched spillway, there are two low concrete structures which serve as overflow weirs under high water conditions (see general plan in Appendix B). Approximately 4 inches above the notched spillway crest, the weirs were in good condition with no indication of cracking or spalling. A steel piped rail extends along the eastern section of the structure across the normal flow spillway as shown in Photo 2.

Photo 2 - View of dam, looking east along the
crest. Note spillway.

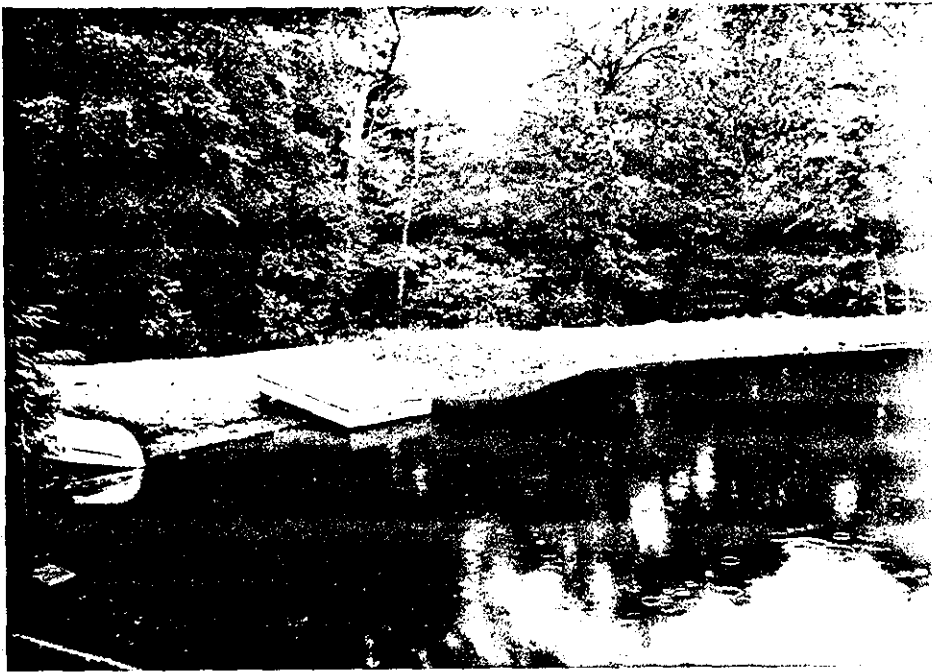
Photo 3 - View of dam embankment looking downstream.

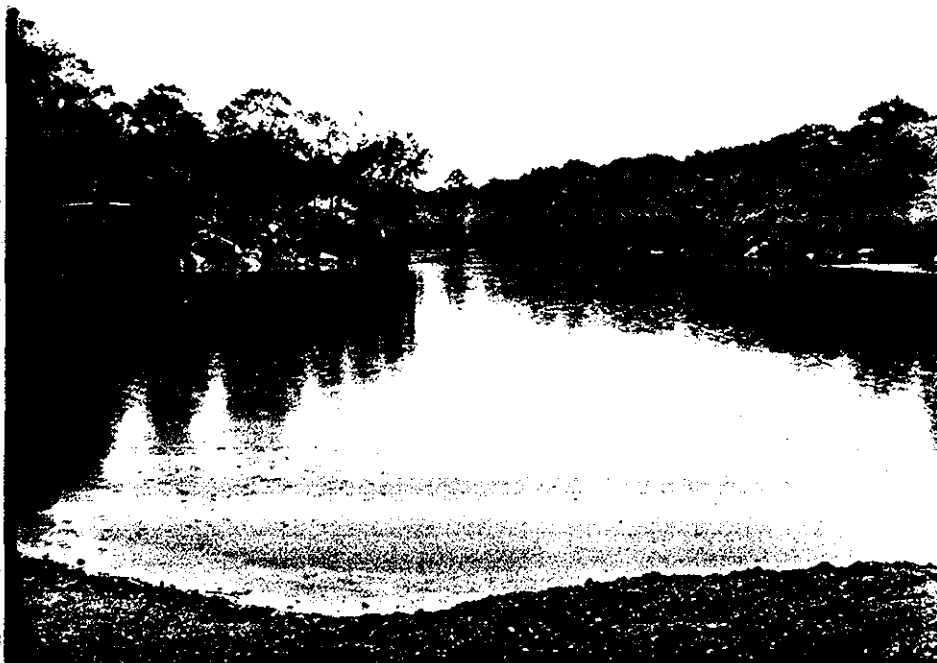
Photo 6 - Upstream reservoir area (Boulder
Lake).
